Bourne Leisure Ltd. Thermal Performance Measurement Report

May 2016

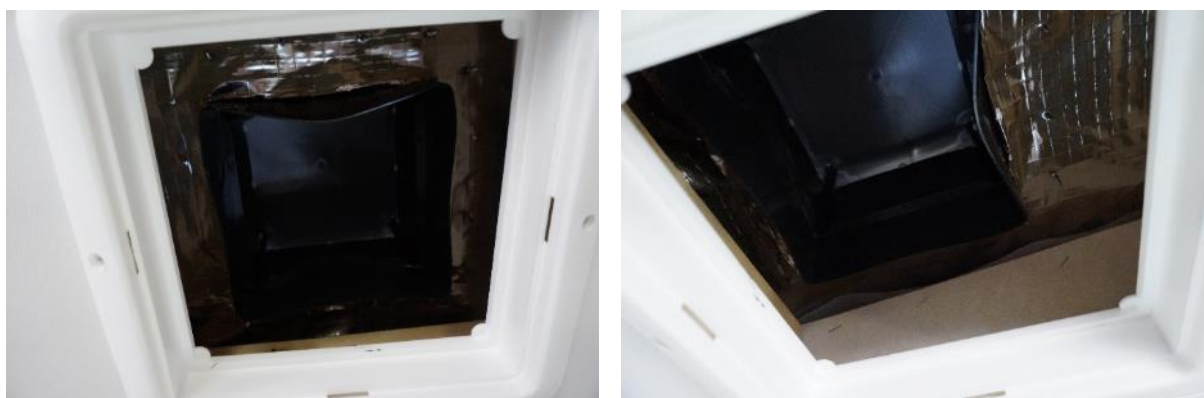
- 46 It is also clear from Figure 46 and Figure 48 that the *in situ* U-values measured at the external wall and roof anomalies are significantly higher than the design intent steady-state U-values. This can be attributed to the excessive thermal bridging that was observed at these locations. In the case of the external wall anomaly, the thermal bridging was caused by the insertion of additional timber at this location to enable the mounting of an external aerial. With respect to the ceiling anomaly, removal of the ceiling extract grille revealed either a lack of, or the omission of insulation surrounding the extract grille (see Figure 51).

Figure 51 Lack of insulation around ceiling extract vent in kitchen area of caravan B.

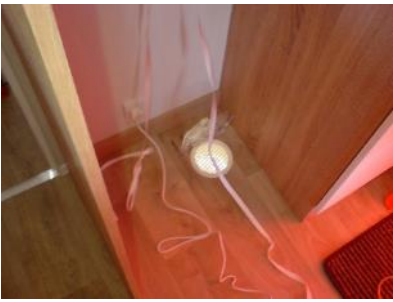
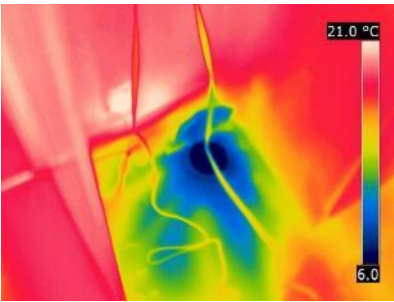
Room – Lounge/Kitchen Span – 10 °C Excessive air leakage observed from under the fridge.

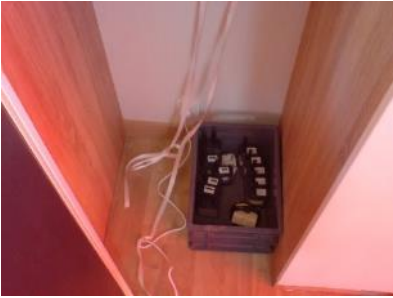
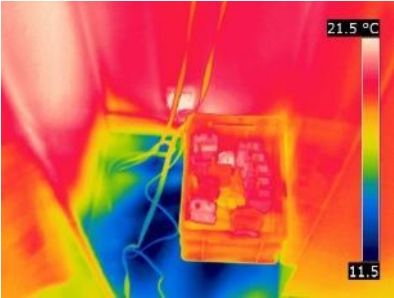
Room – Lounge/Kitchen Span – 15 °C Fridge removed to reveal the temporary sealing below the fridge had become displaced.

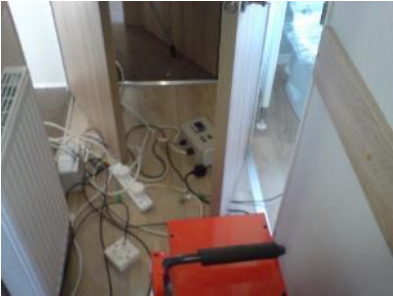
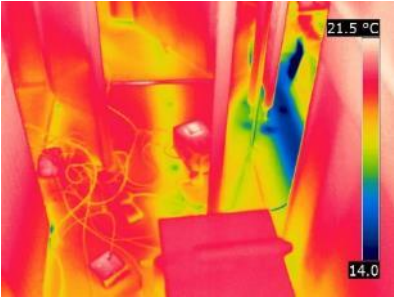
Room – Lounge/Kitchen Span – 10 °C Temporary sealing over the grille was replaced and a box placed over the sealed grille to keep the seal in place and the test was re-run.
